Crocker Reef Aid to Navigation (Buoy #16) Coral Reef Injury Restoration and Monitoring

Bill Goodwin
Florida Keys National Marine Sanctuary
Marine Resources Manager

National Marine Sanctuaries National Oceanic and Atmospheric Administration

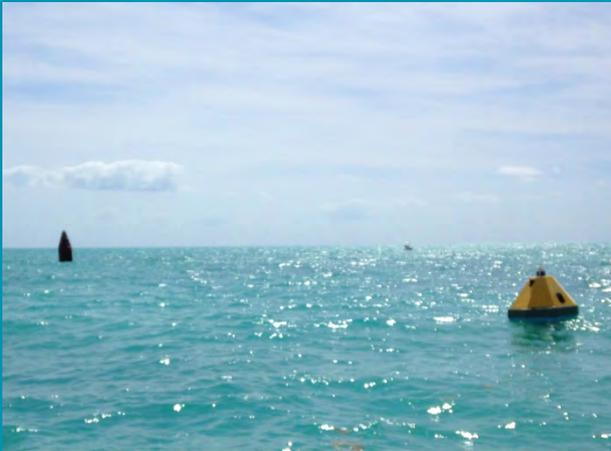
Researchers from NOAA's Atlantic Oceanographic and Meteorological Laboratory (AOML) notified FKNMS of coral reef injury caused by CR ATON on April 11, 2014

Injury assessment conducted by FKNMS staff documented an injury path that measured 64.5 meters (approximately 212 feet) in length

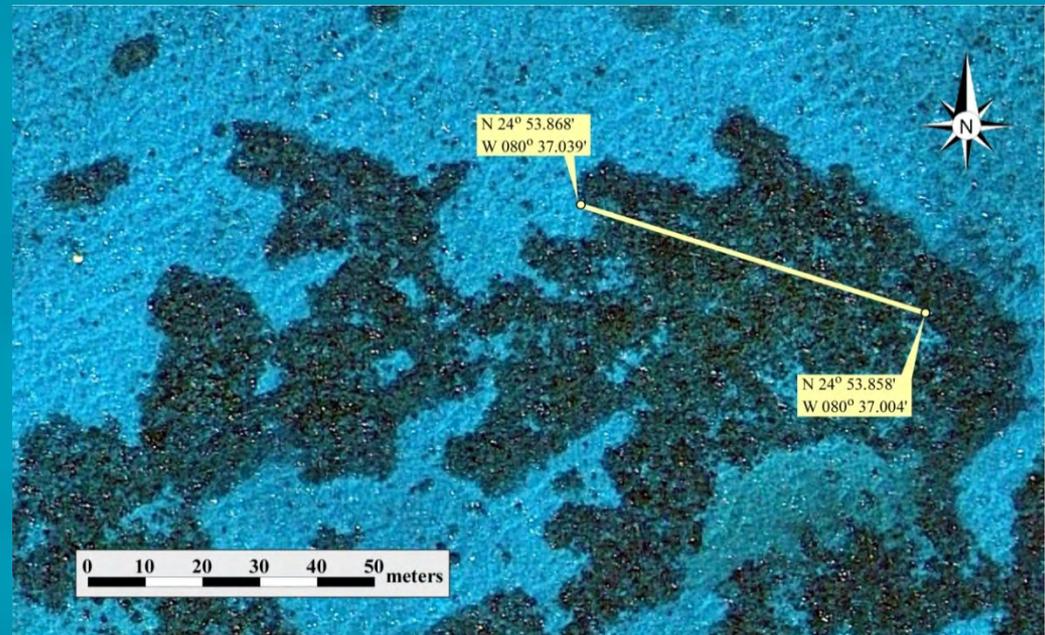
Injury types at CR ATON site :

Living tissue abrasion

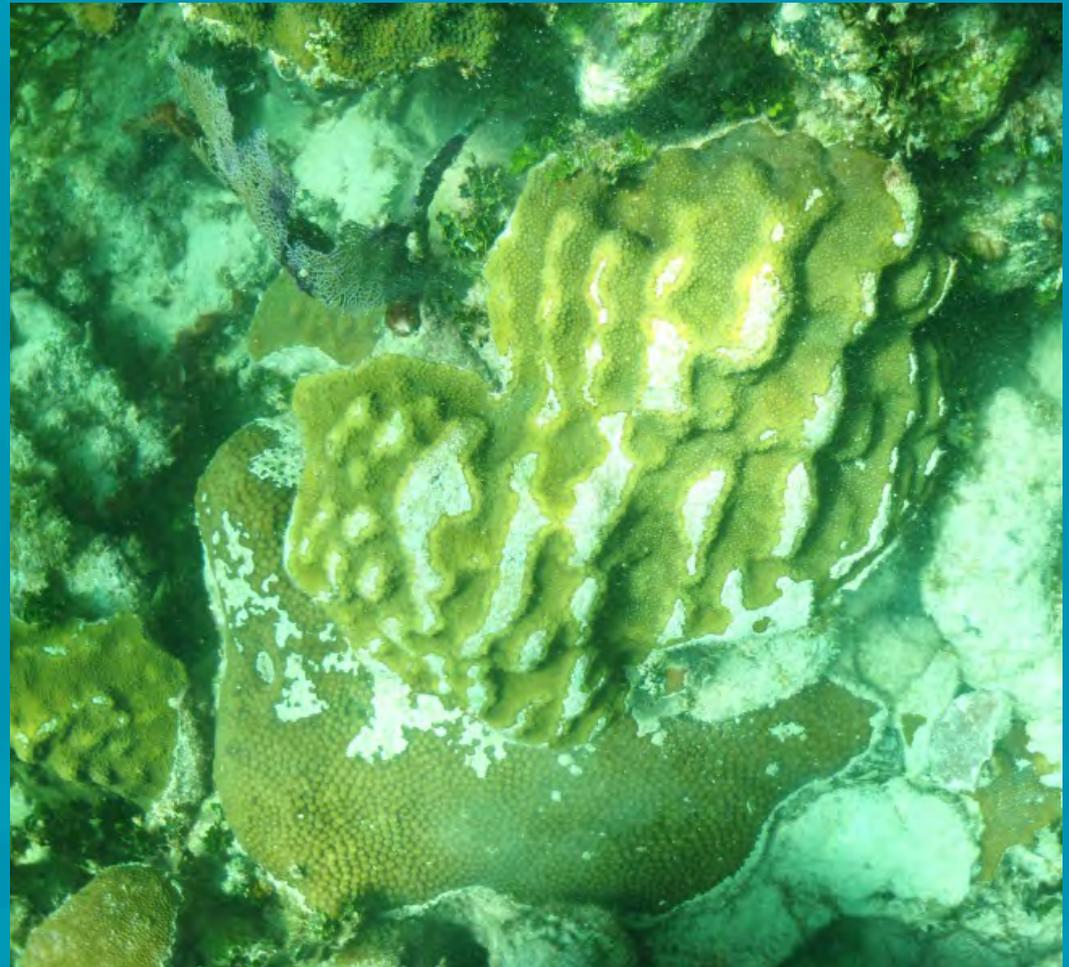
Injury types at CR ATON site :

Fracturing of coral colonies

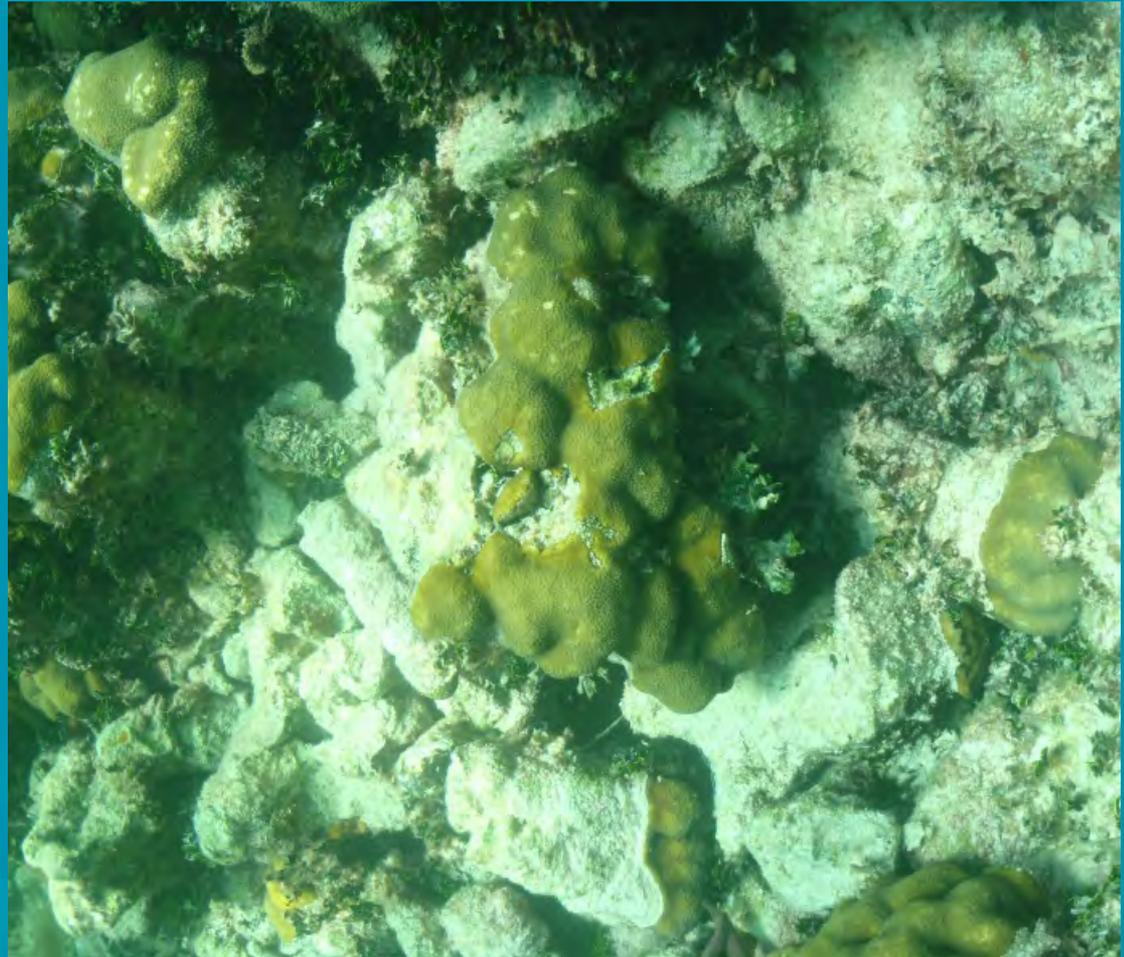
Injury types at CR ATON site :
Dislodging of coral colonies

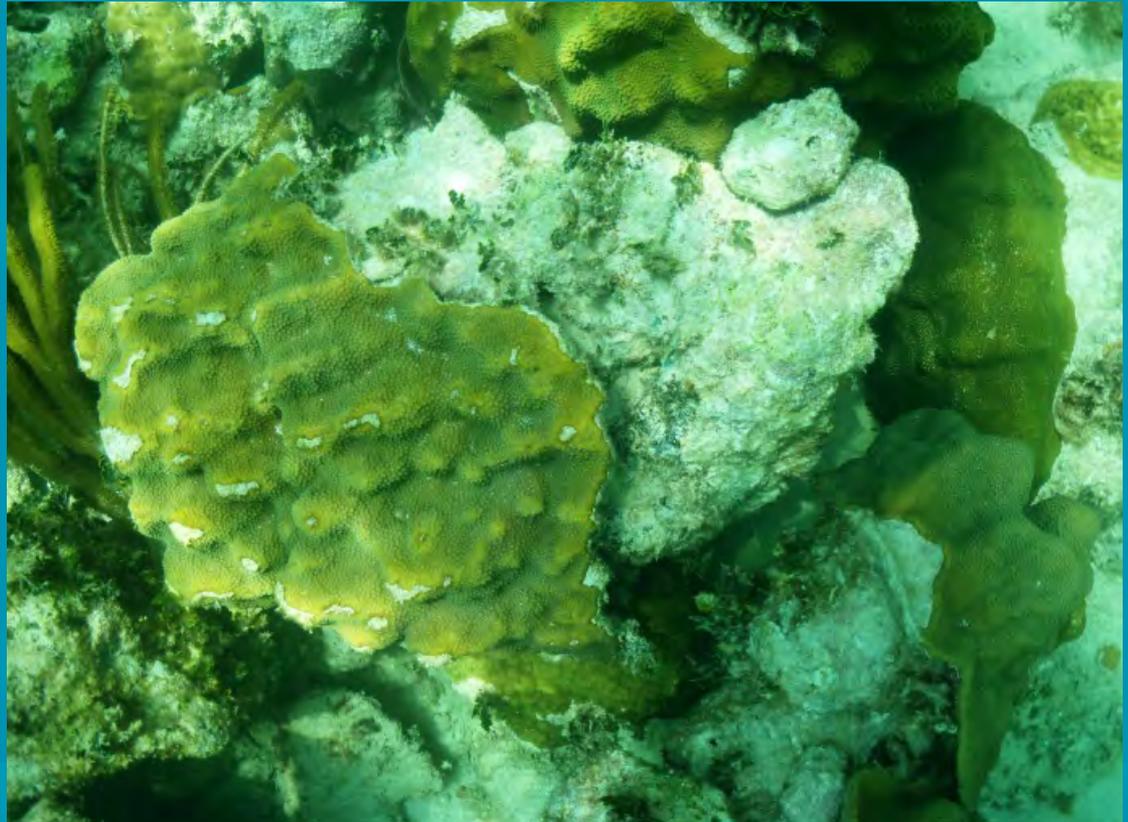
Injury types at CR ATON site :

Generation of loose framework rubble

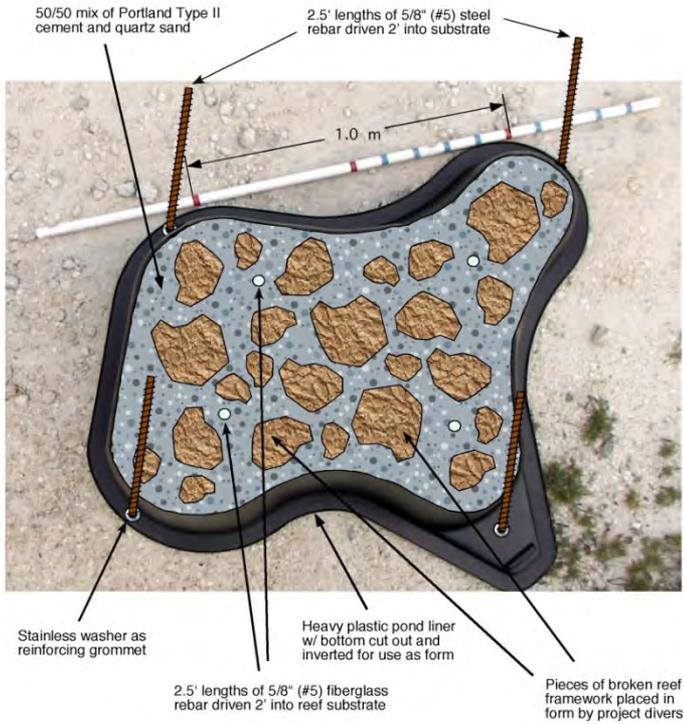
Area of “Reeform” = 1.25 m²

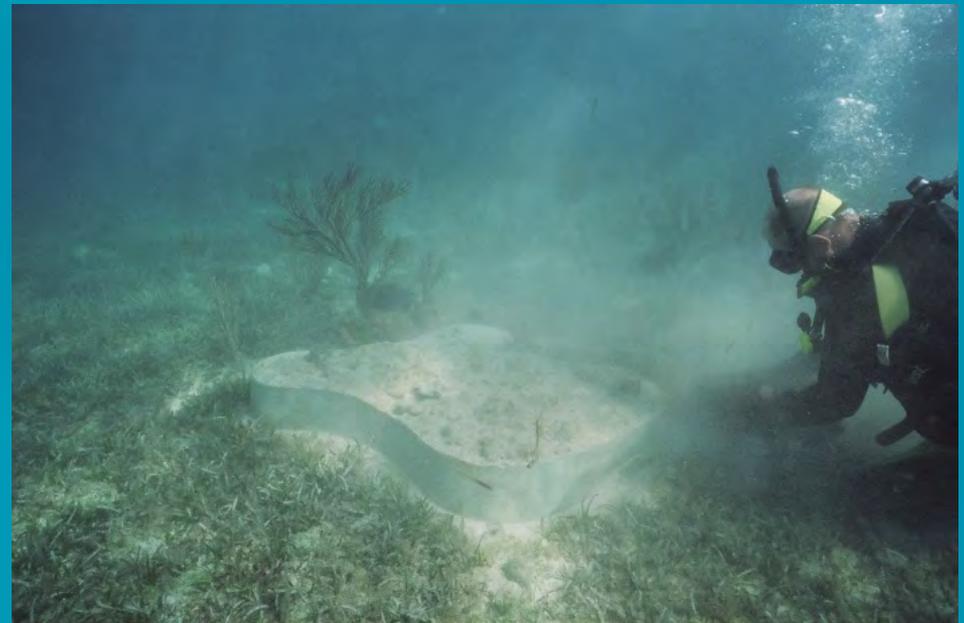
Construction of pilot module at *What Doin'?* grounding restoration site in February 2009

What Doin'? module with rubble dressing stones and corals attached

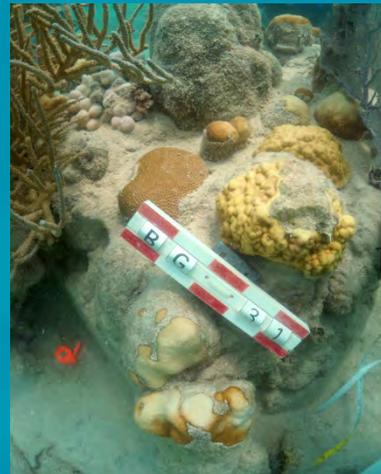
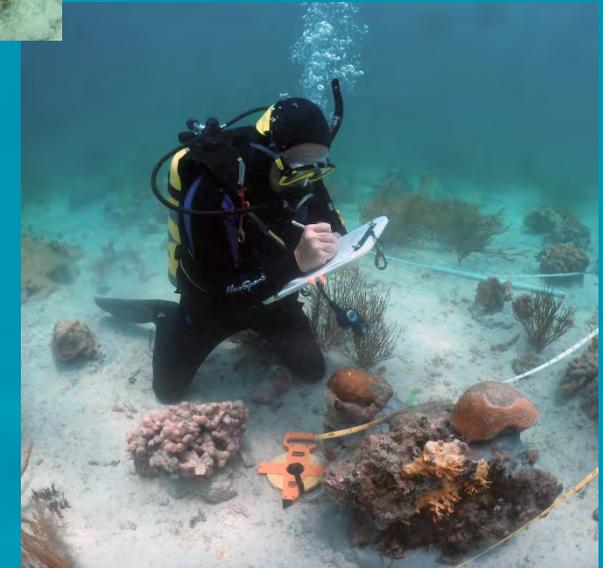
The day after completion of the project, a baseline monitoring event is conducted
