Important to Obtain Readily Available, Site Specific Data For Large Quantity Discharges Of Wastewater From Shallow Wells.

FKNMS ADVISORY COUNCIL, February 16, 2016.

PUBLIC COMMENT OF JAN M. EDELSTEIN.

Aquifer Test Report - Cudjoe Key Wastewater Treatment Plant

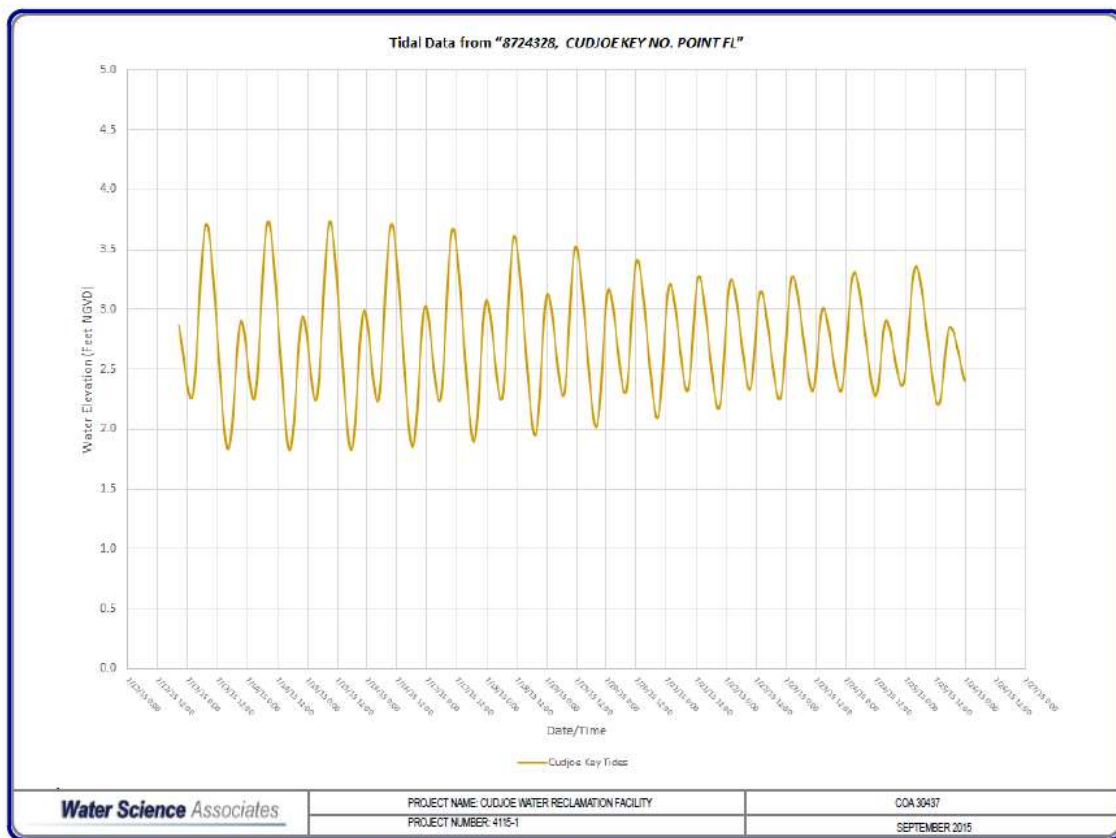
FIGURE 7. HYDROGRAPH OF TIDAL WATER ELEVATIONS FROM CUDJOE KEY TIDAL STATION

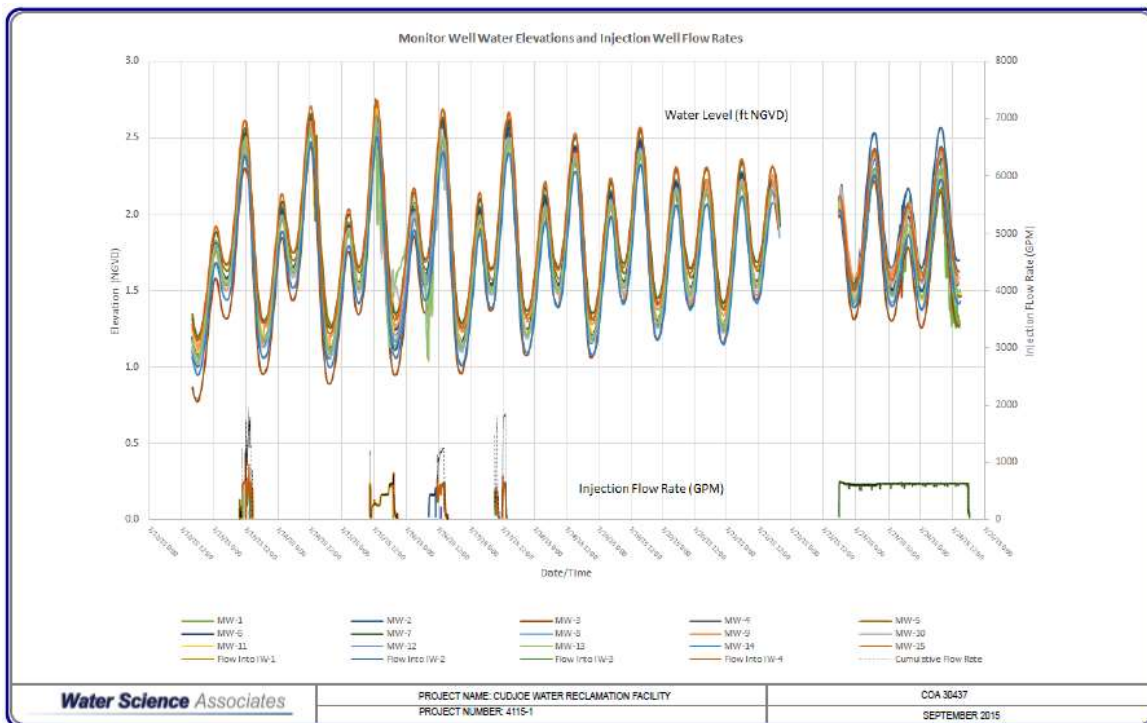
FIGURE 8. WATER ELEVATIONS IN MONITOR WELLS AND INJECTION RATES BETWEEN JULY 12 AND 23, 2015

...our findings regarding connectivity were later substantiated by the results of the Water Science Associates work for the FKAA entitled “Aquifer Test Report – Cudjoe Key Wastewater Treatment Plant” as shown on their Figure 8. Their water elevation curves in ALL monitoring wells are parallel, with practically the same wavelength and the same amplitude, and without any lag....**In summary ... there is an undeniable ... connection between the injection depth (80’ to 120’) and surface waters.**

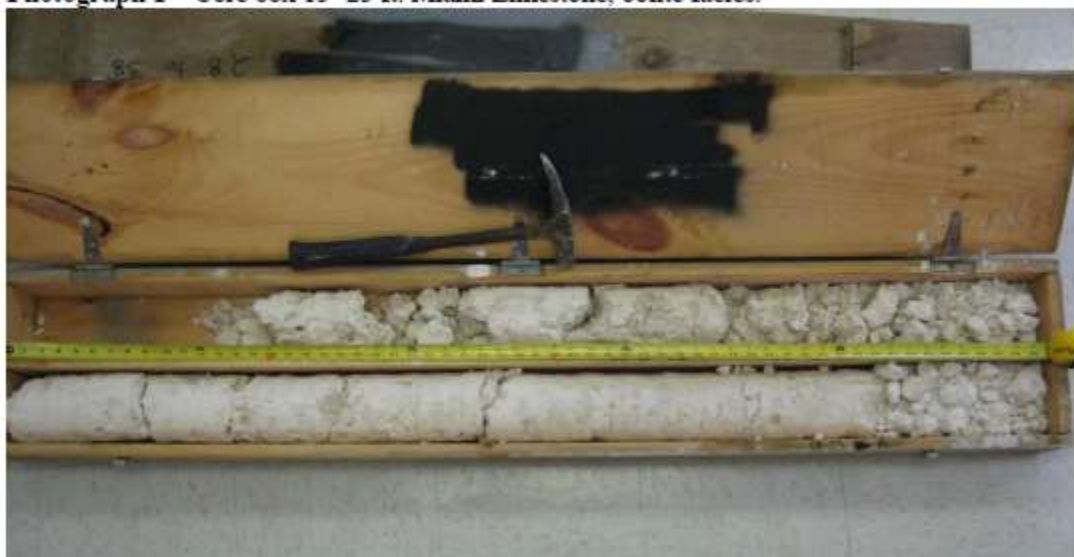
Photograph 1 – Core box 13 -23 ft. Miami Limestone, oolite facies.

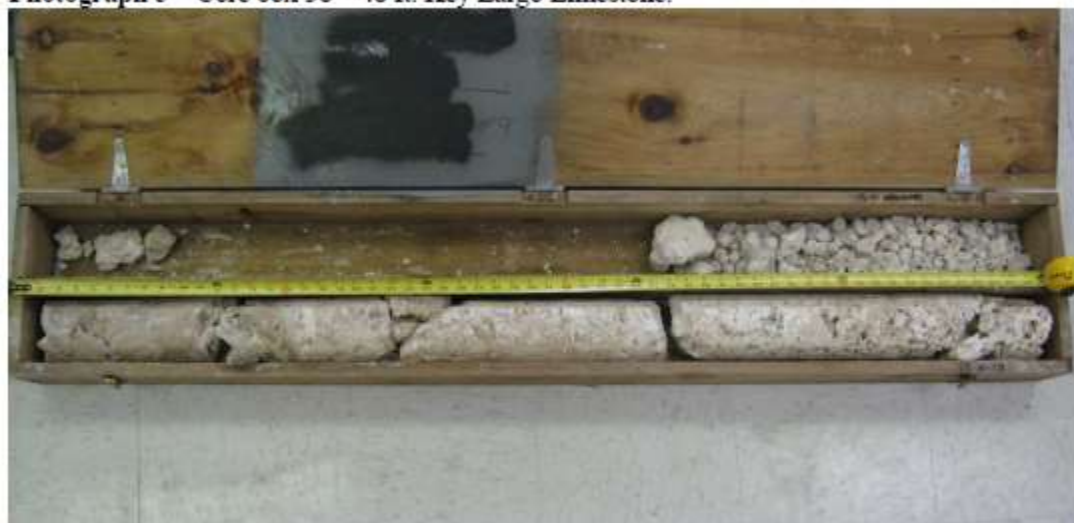
Photograph 5 – Core box 38 – 48 ft. Key Largo Limestone.

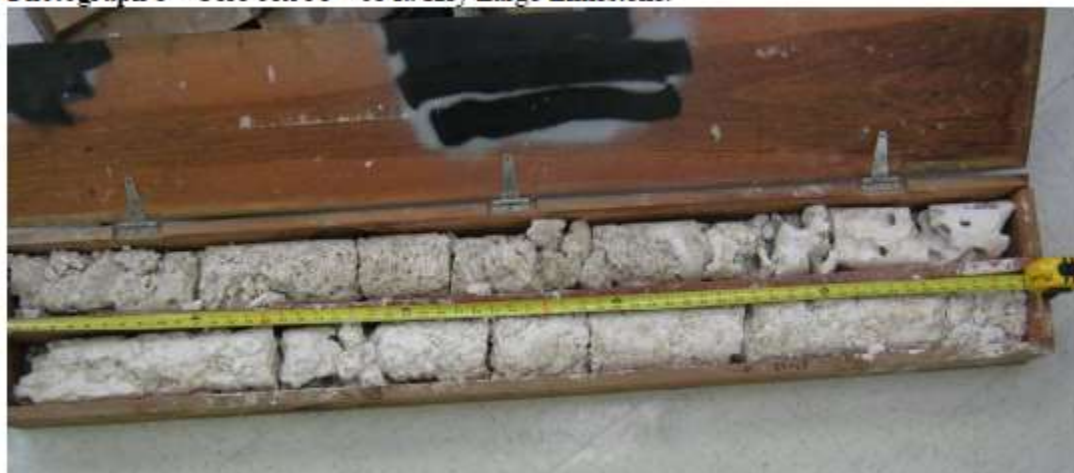
Photograph 8 – Core box 58 – 68 ft. Key Largo Limestone.

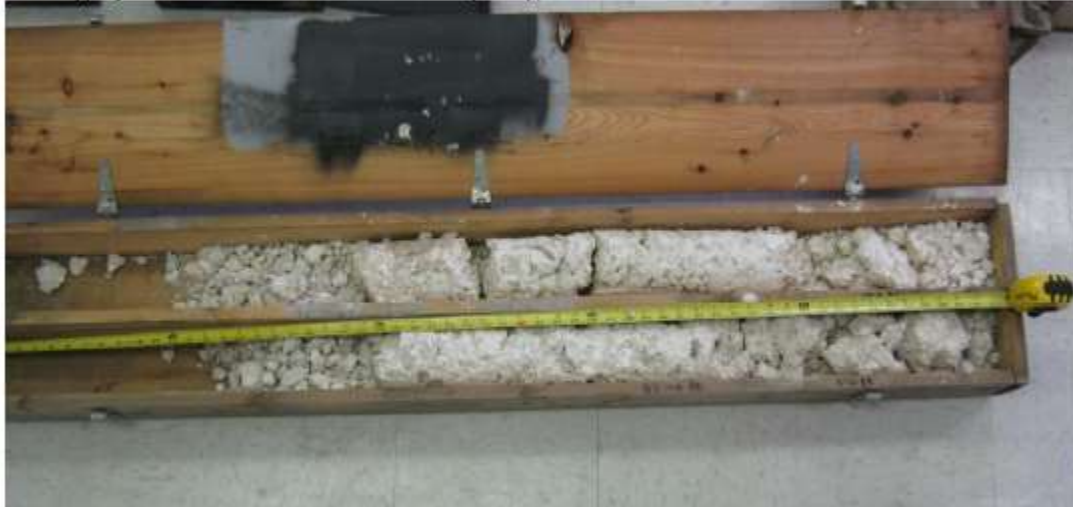
Photograph 12 – Core box 78 – 88 ft. Key Largo Limestone.

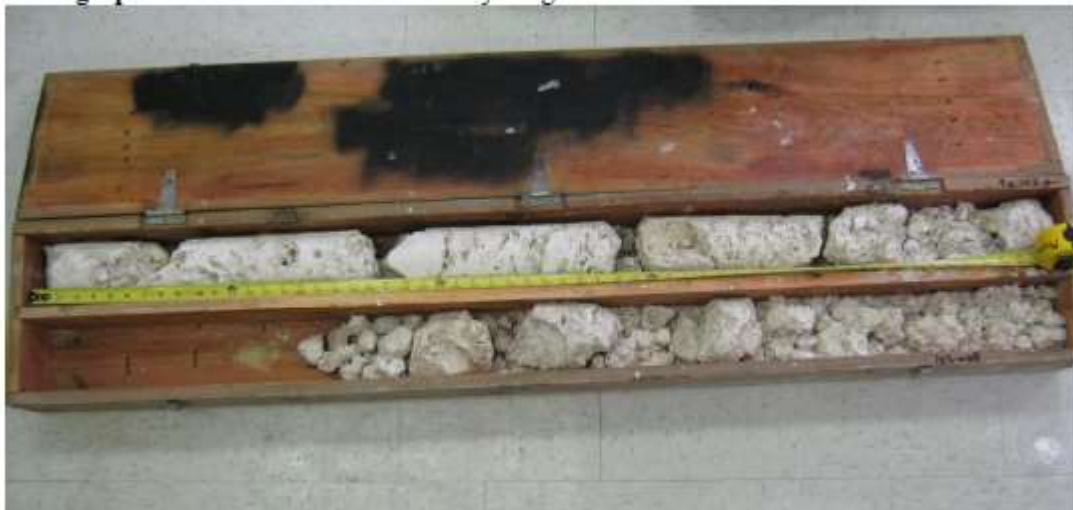
Photograph 14 – Core box 98 – 108 ft. Key Largo Limestone.

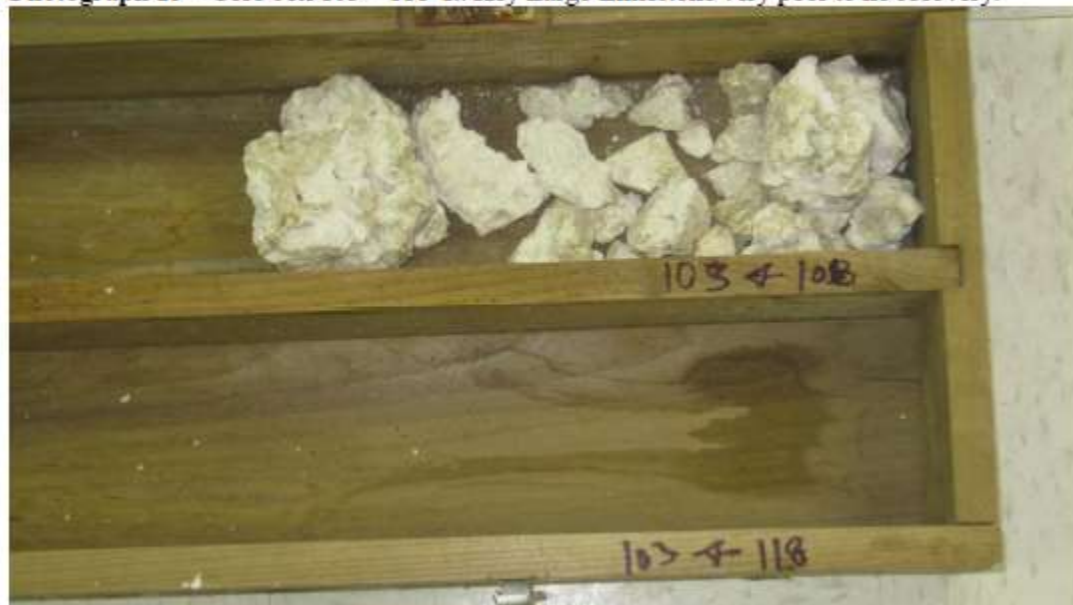
Photograph 15 – Core box 103 – 118 ft. Key Largo Limestone very poor to no recovery.
