Sponsored by the Florida Keys Environmental Fund and Monroe County
Presented to the FKNMS Sanctuary Advisory Council February 21, 2017

Current Mapping Effort

Project Purpose - To create a new, scientifically valid map dataset for the FKNMS to allow a management focus on the location of scarred and impacted shallow benthic habitats; and to allow analyses of trends through comparison to vessel impacts mapped 20 years ago

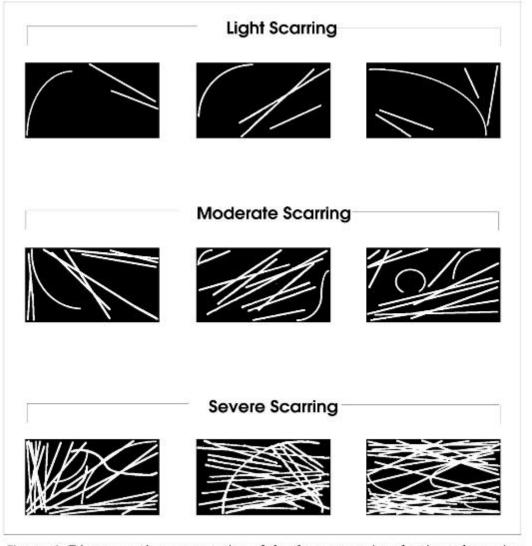
Figure 6. Diagrammatic representation of the three categories of estimated scarring intensity. Black space within each block represents seagrasses, and white marks represent scarring. Light scarring is defined as the presence of scars in less than 5 percent of the delineated polygon, moderate scarring as the presence of scars in 5 to 20 percent of the polygon, and severe scarring as the presence of scars in more than 20 percent of the polygon.

Using 3 levels of impact as in 1995 mapping = Light/Moderate/Severe

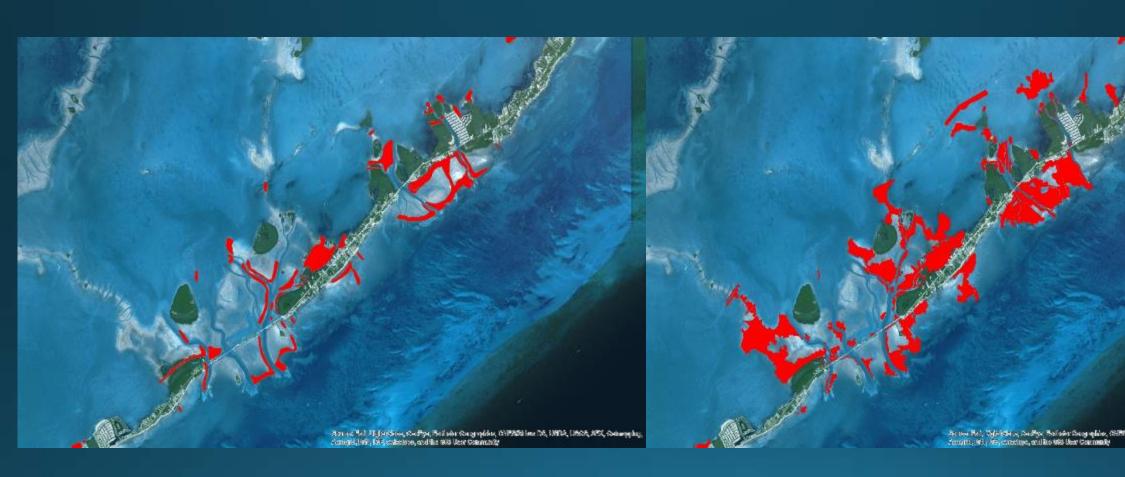
Middle Keys - 'Severe' Impacts Mapped 1995 and 2015

1995 2015

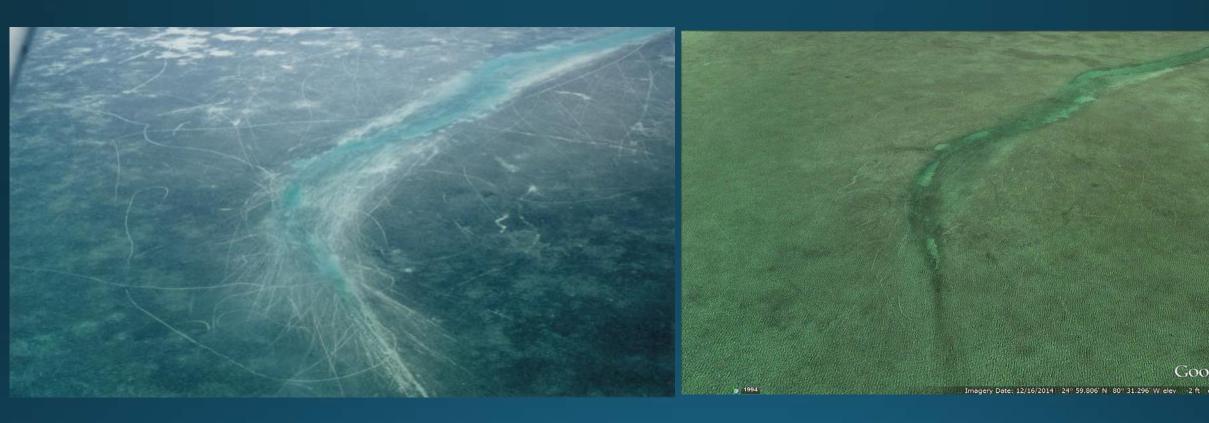
1998 - Kruer Photo Tavernier Key WMA 2014 Tavernier Key WMA

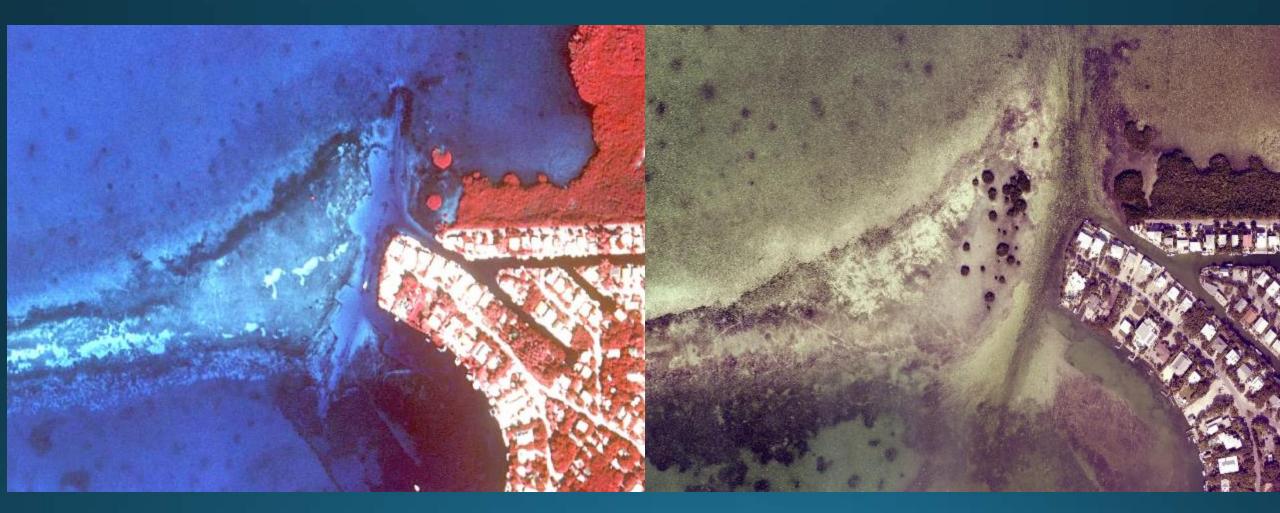
Increased Impacts from 1995 to 2015 – bayside of Plantation Key

1995 2015

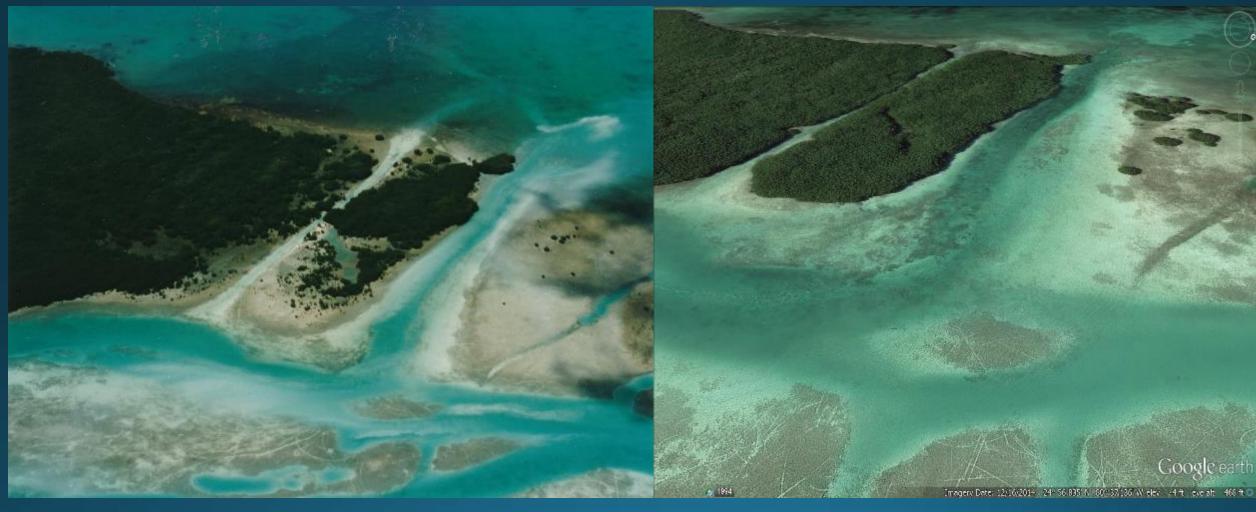
Increased Impacts from 1995 to 2014 – bayside of Whale Harbor

1995 2014
