Seagrasses and water quality in the FKNMS after Hurricane Irma

FKNMS Sanctuary Advisory Committee Meeting
October 16, 2018 – Marathon, FL

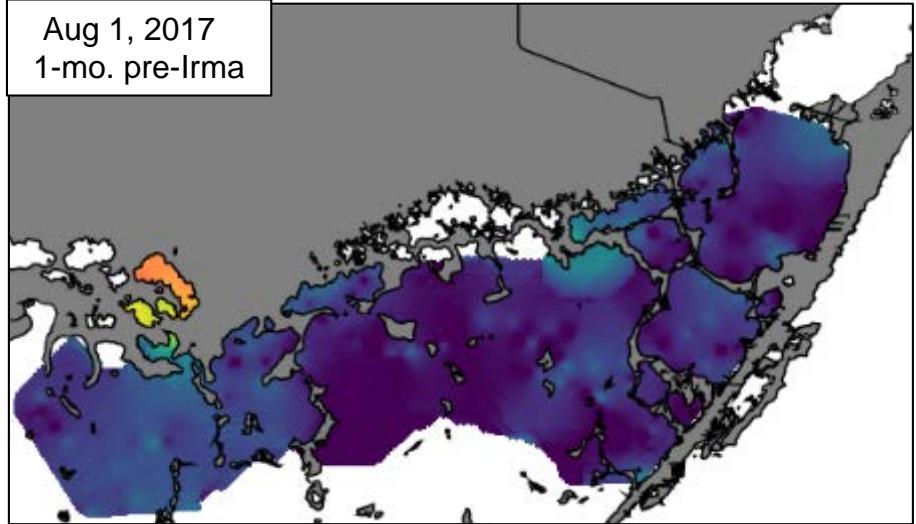
Aug 1, 2017
1-mo. pre-Irma

Chla in NE/Central Florida Bay Due to Hurricane Irma ($>5 \mu\text{g/l}$ = Algal Bloom)

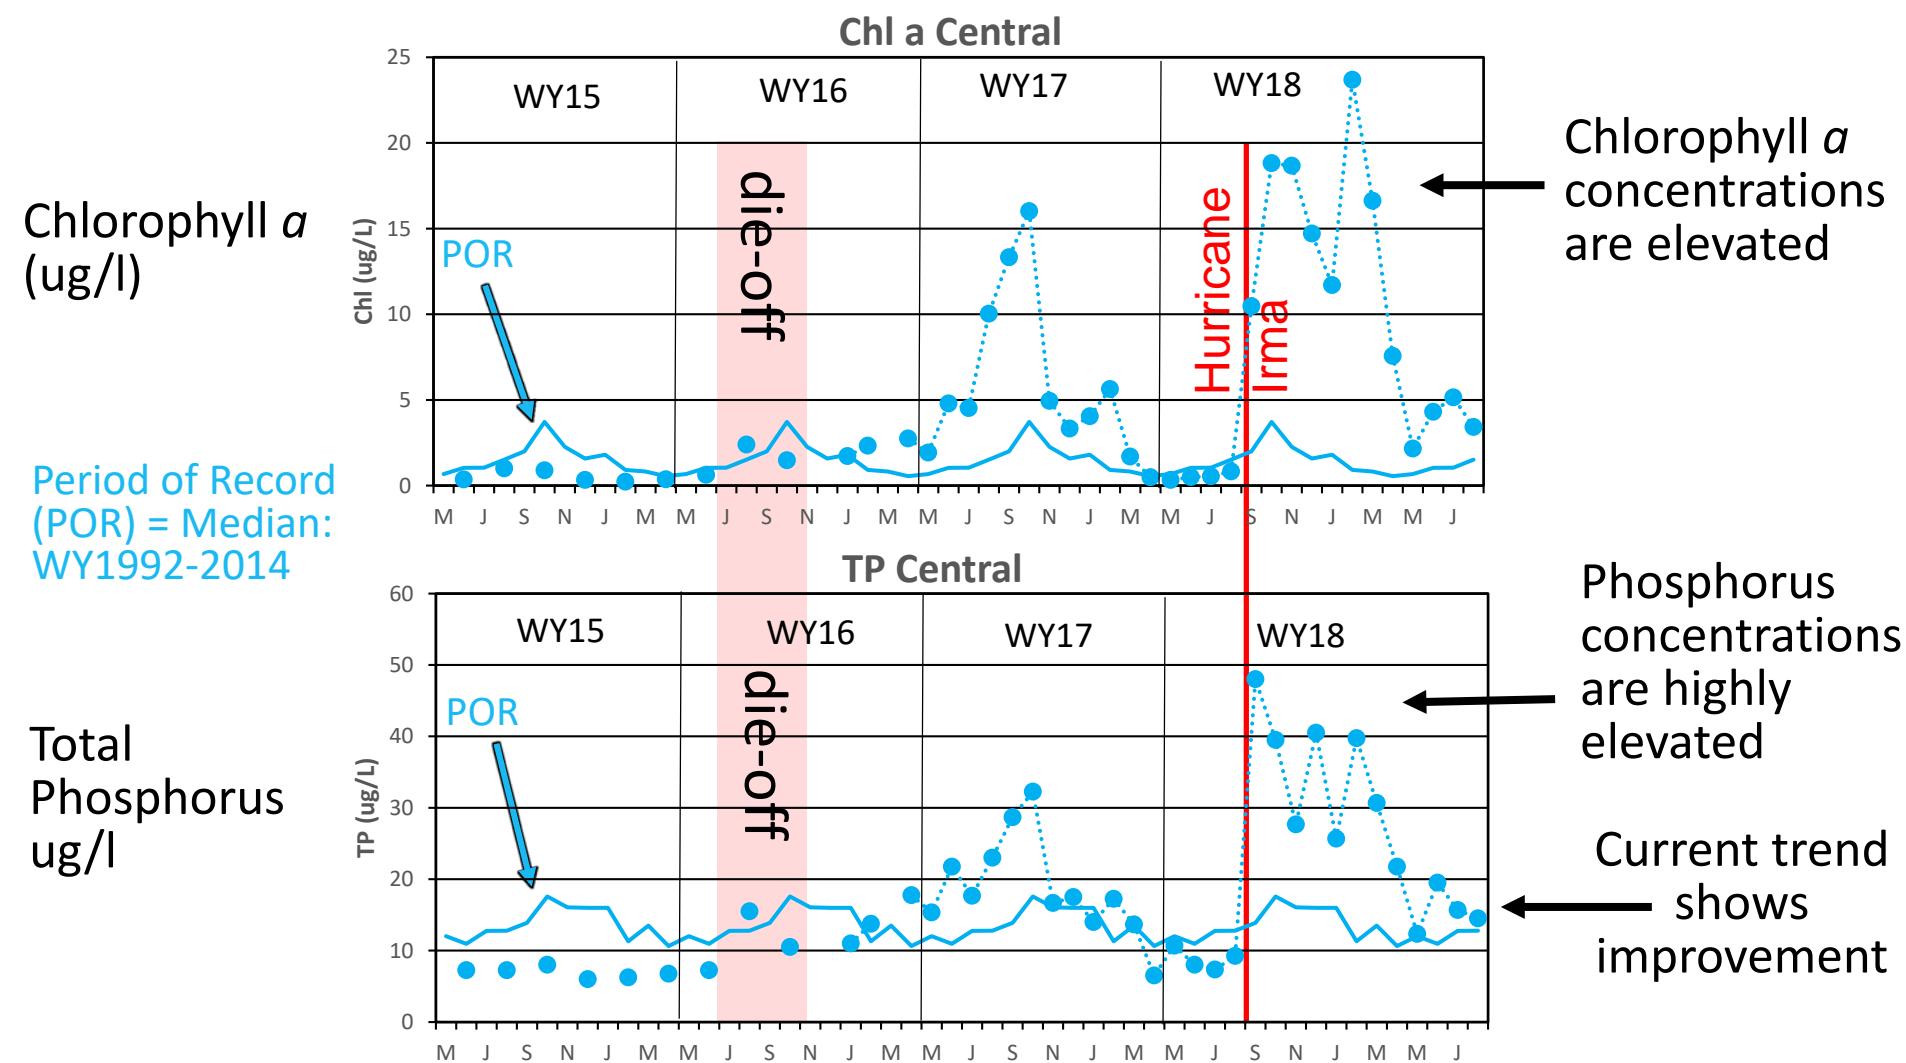
Water Quality Patterns in Central FI Bay: Die-off and hurricane impact

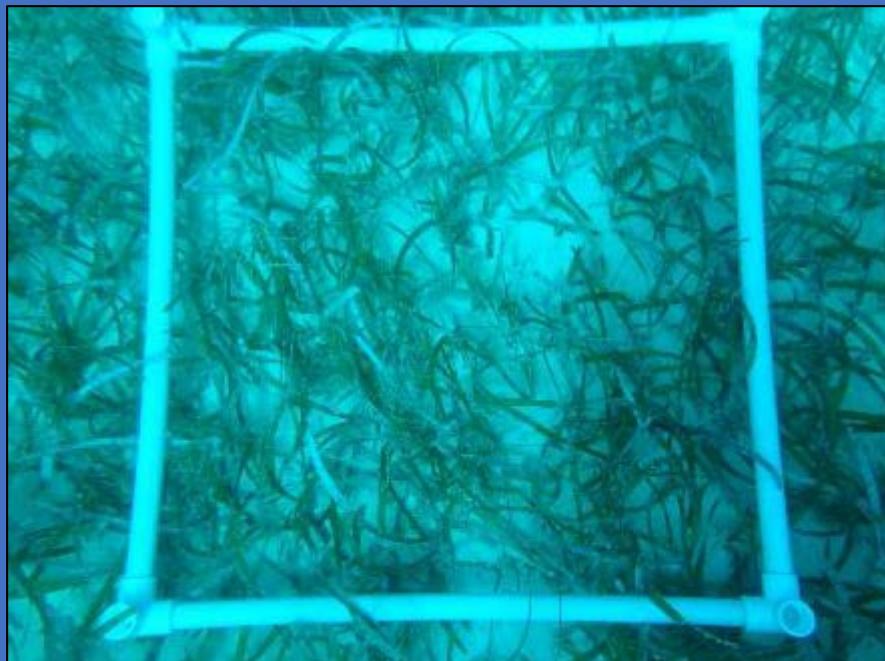
June 2017

Erosion or Burial at Site 243?

Half of quadrats had lush Tt,
half were bare

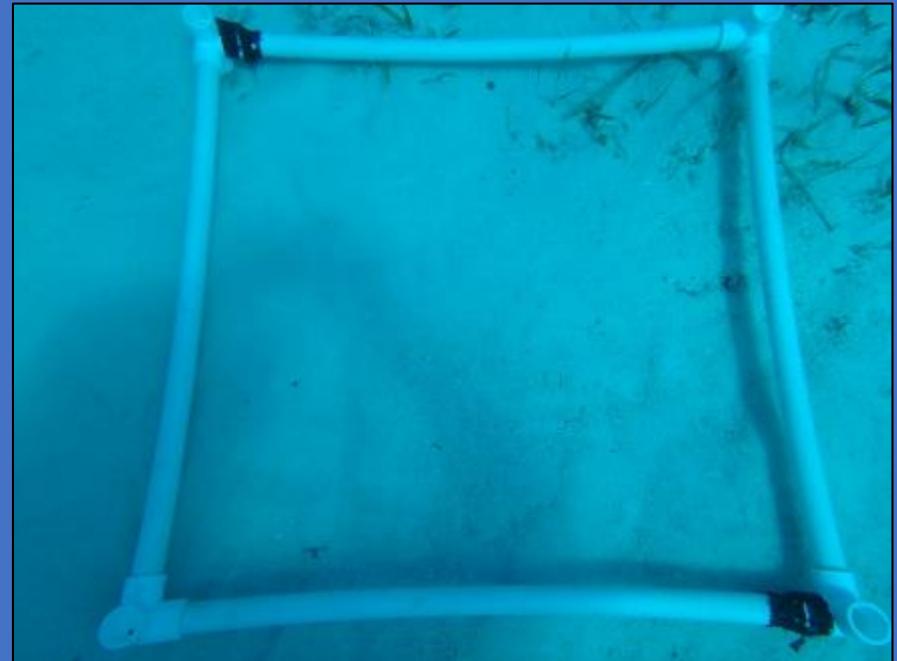
October 2017

Only quadrat left with
seagrass

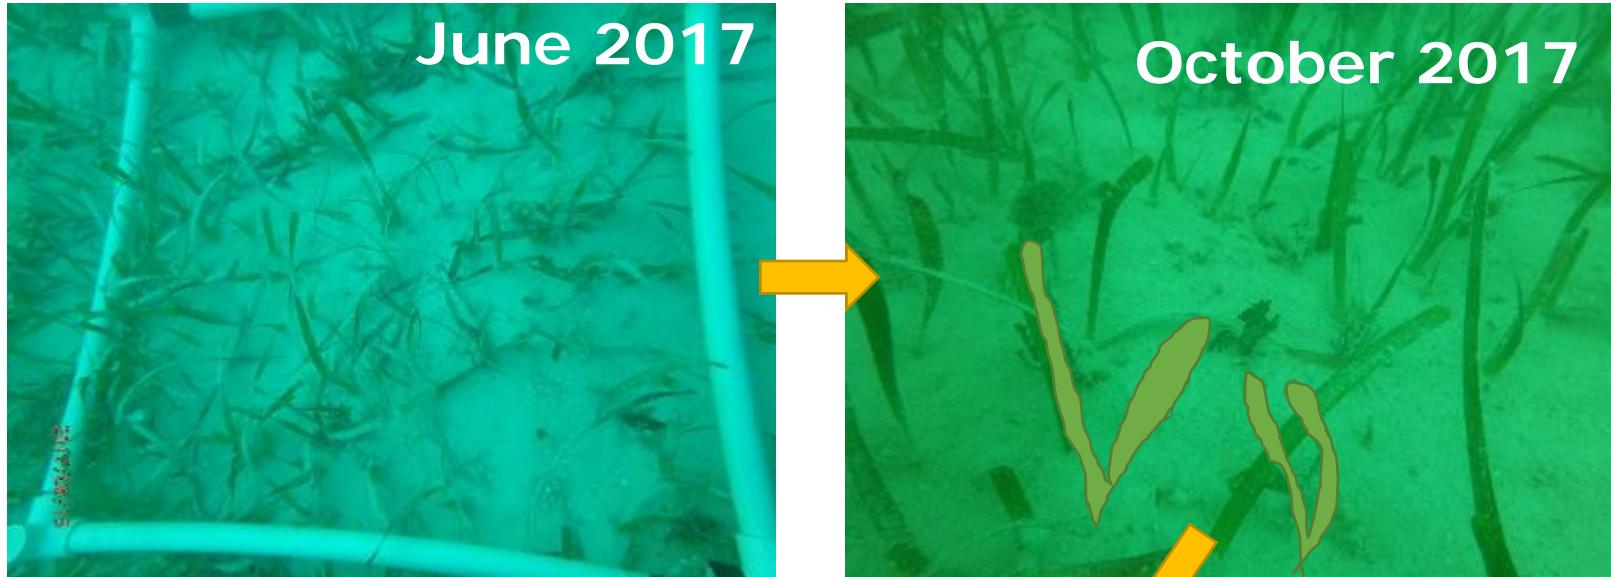
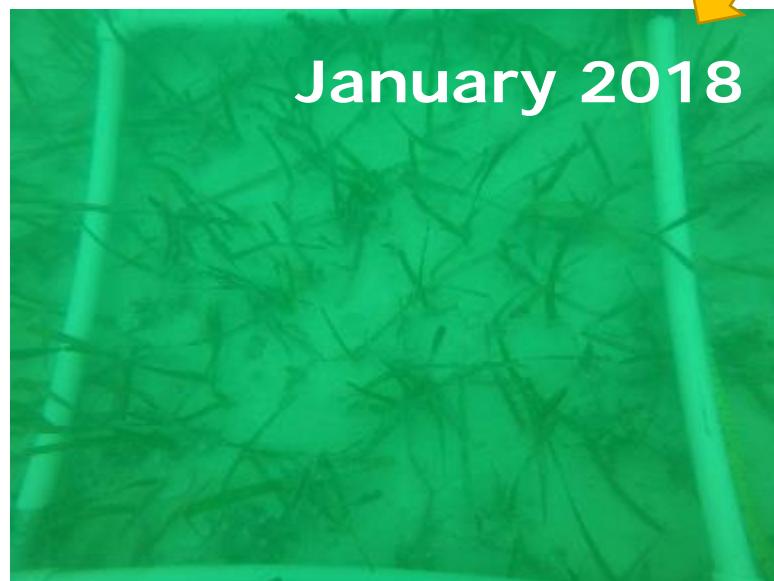
Burial at Site 269

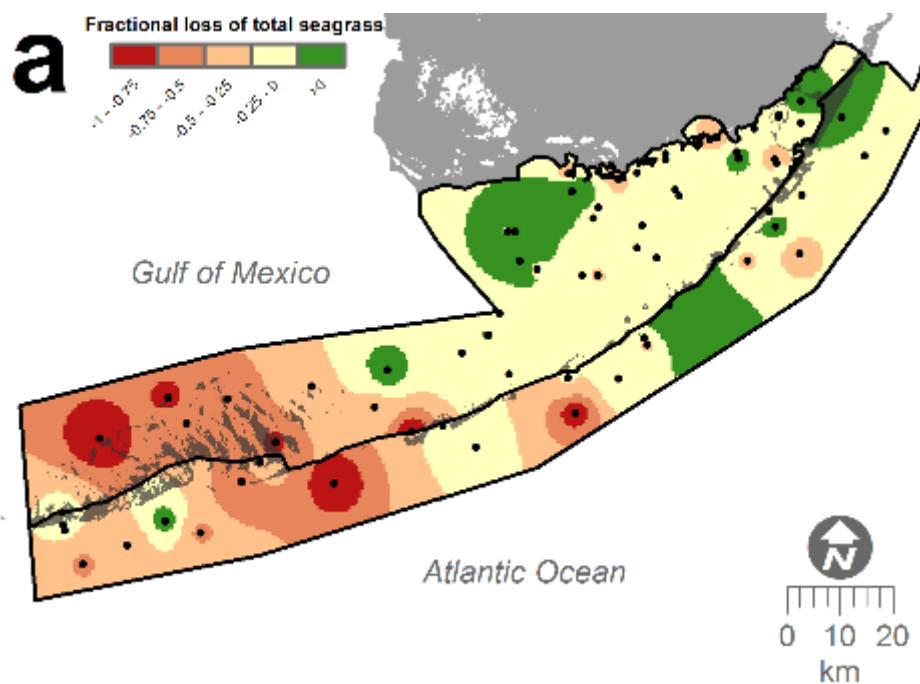
Seagrass

Spatial pattern in short-term response

(comparing post-Irma to pre-Irma seagrass and macroalgae abundance)

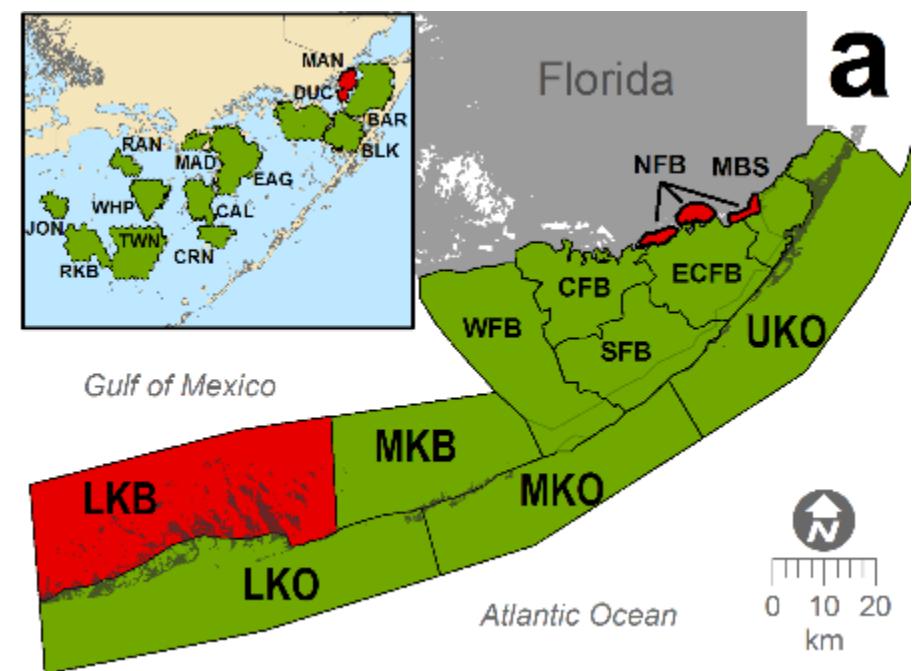
a

Nonparametric repeated measures analysis of variance

(Compares Fall/Spring 2017 changes to Fall/Summer 2012-2016 changes)

Seagrass

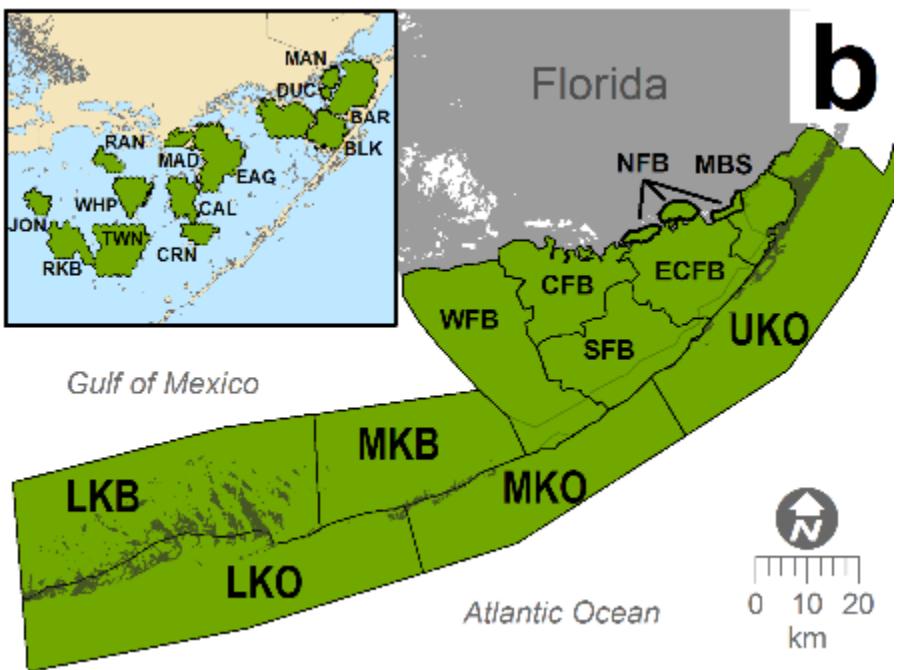
b

Macroalgae

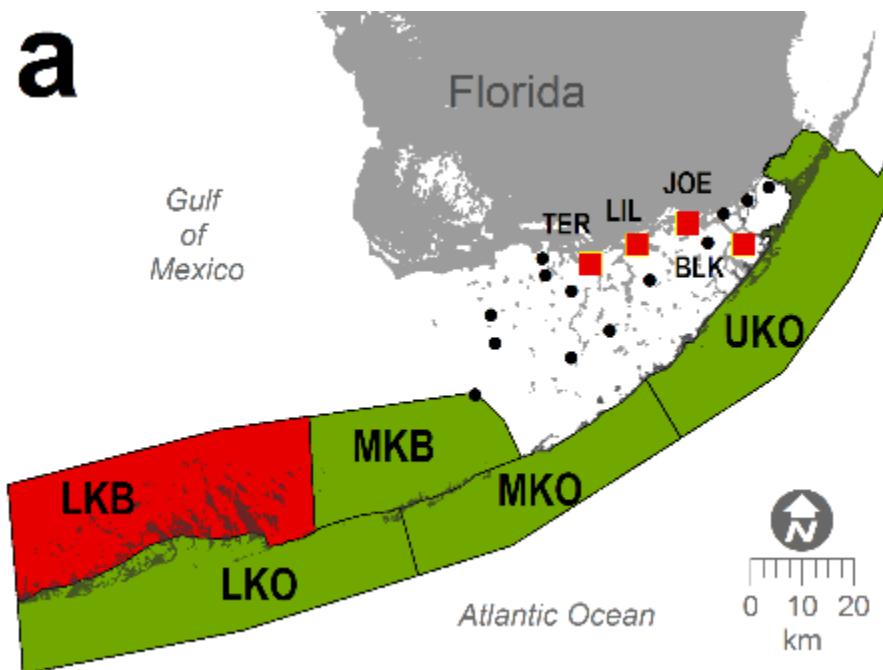
a

Seasonal change analyses

(Compares Fall/Spring 2017 changes to Fall/Summer long-term changes using several statistical methods)

Seagrass

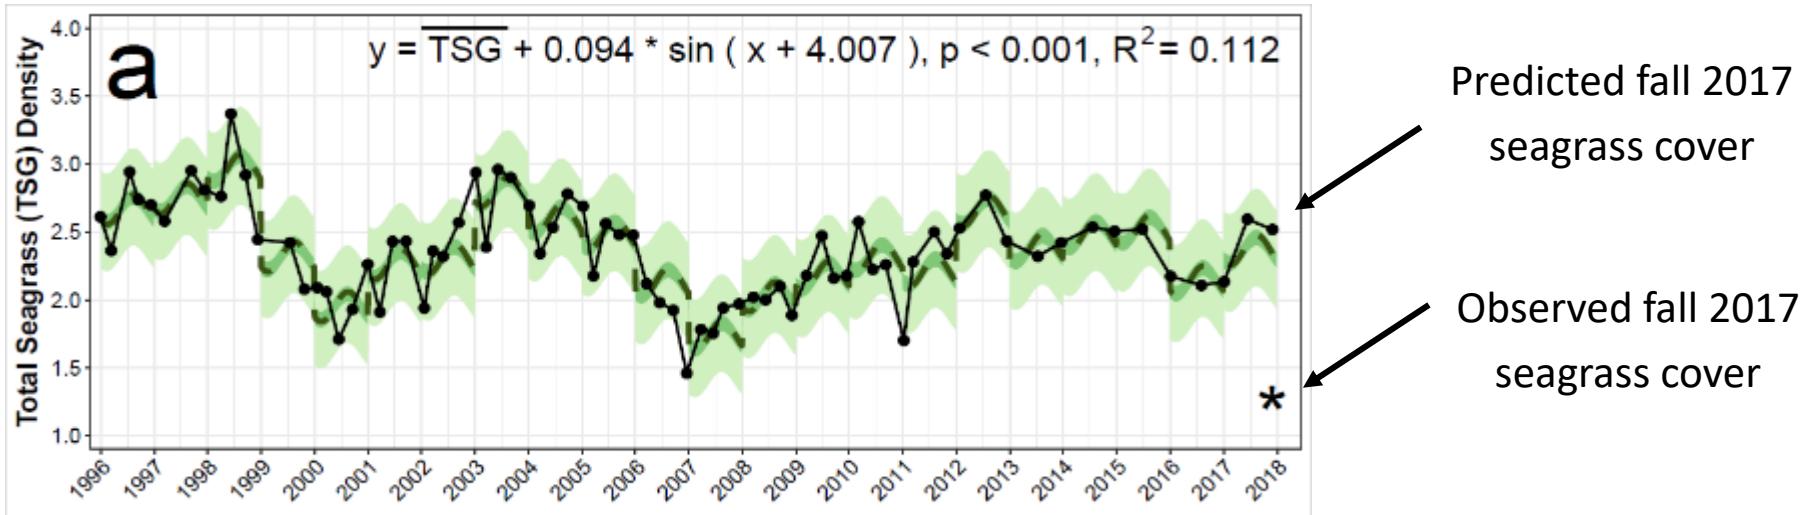
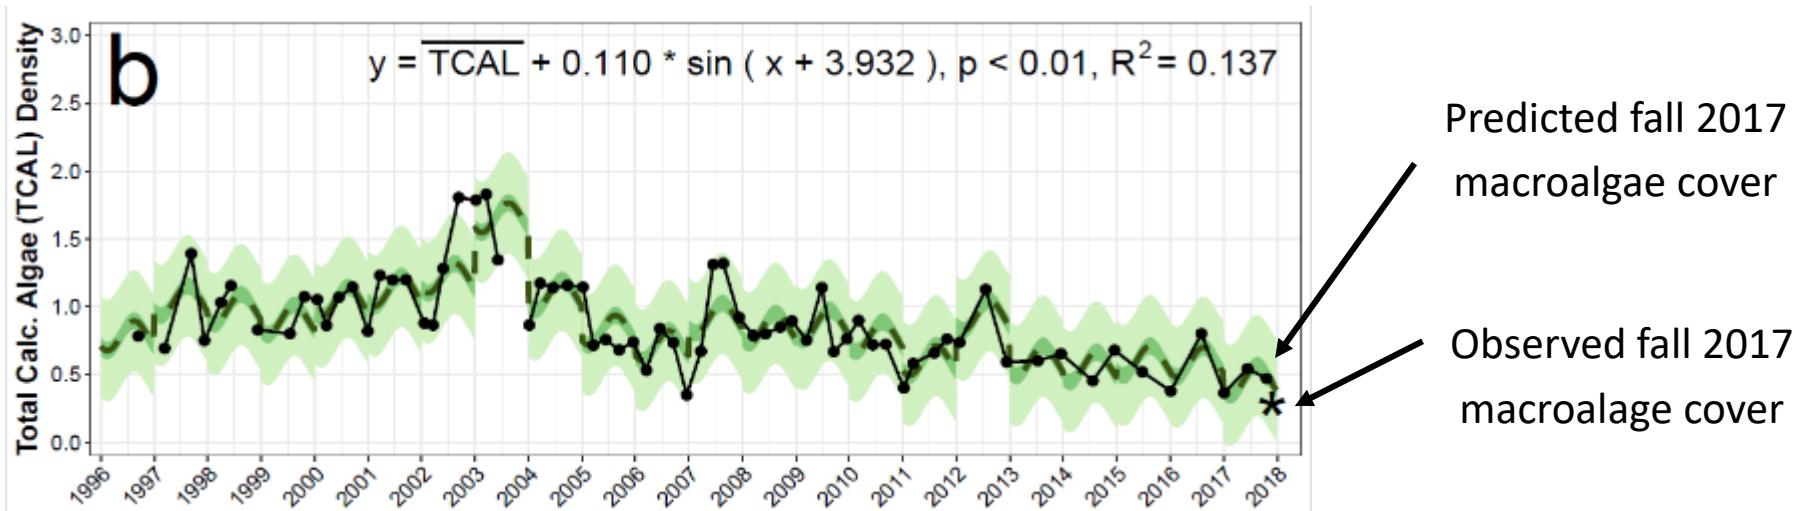
FKNMS seasonal change analysis

(Uses data from 1995-2017 to predict fall 2017 seagrass/macroalgae cover)

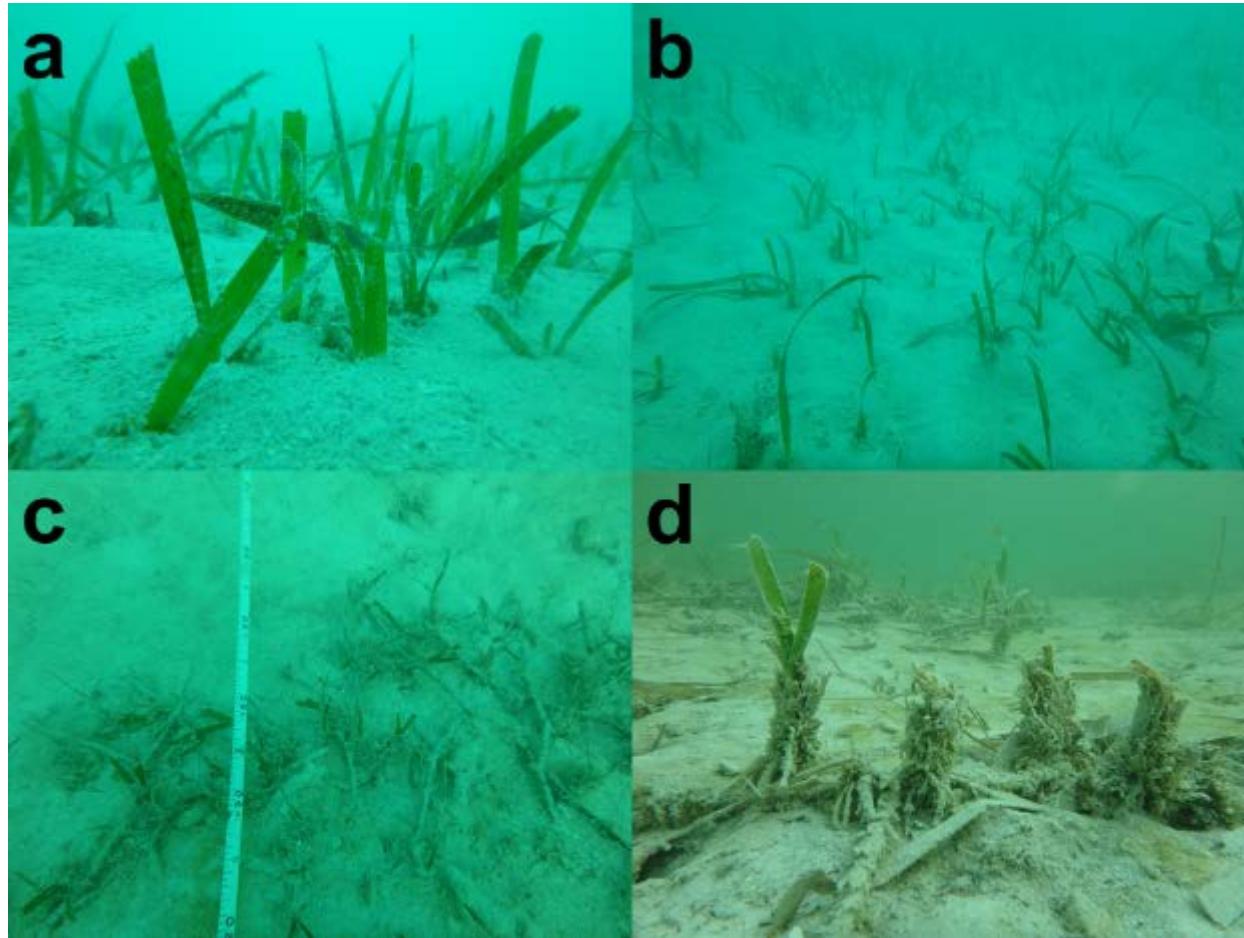
- a. Moderate (5-10 cm) burial after Hurricane Irma at FKNMS site 255
- b. Moderate (5-10 cm) burial after Hurricane Irma at FKNMS site 239
- c. Strong seagrass erosion after Hurricane Irma at FKNMS site 276
- d. Erosion (background) and canopy thinning (foreground) at FKNMS site 294

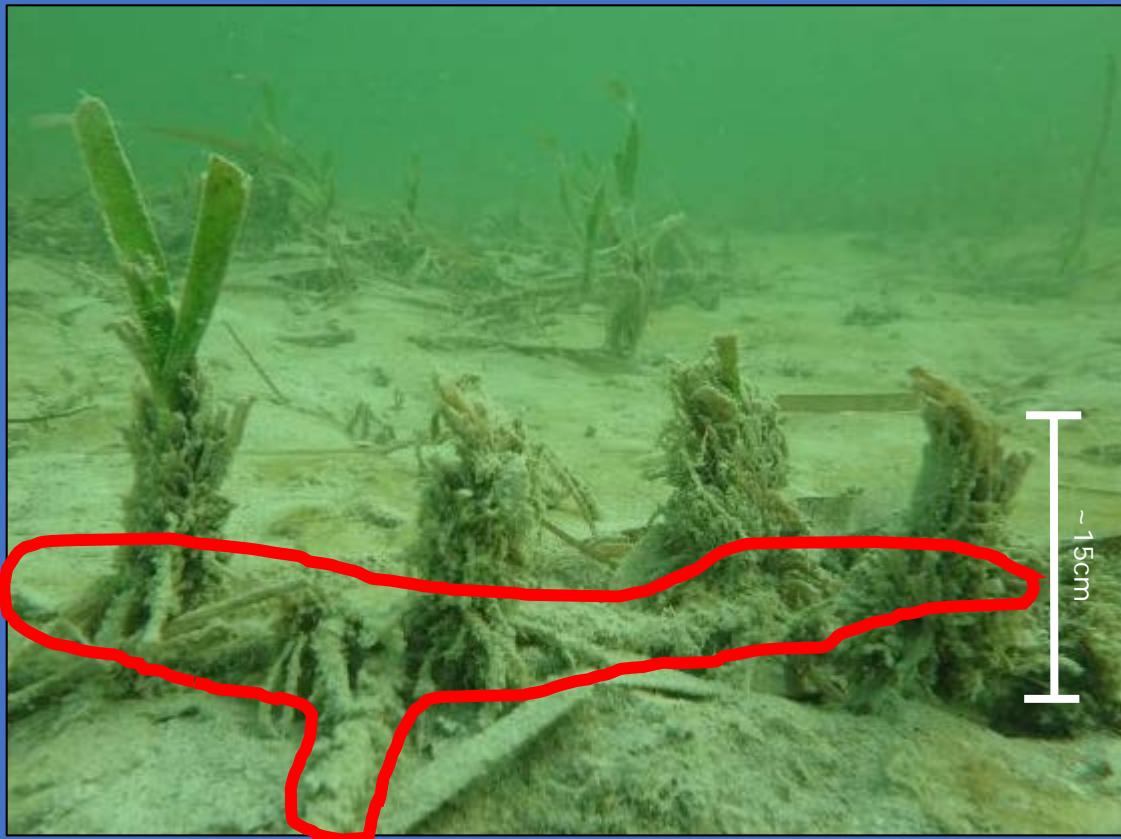
Erosion and Thinning at Site 294

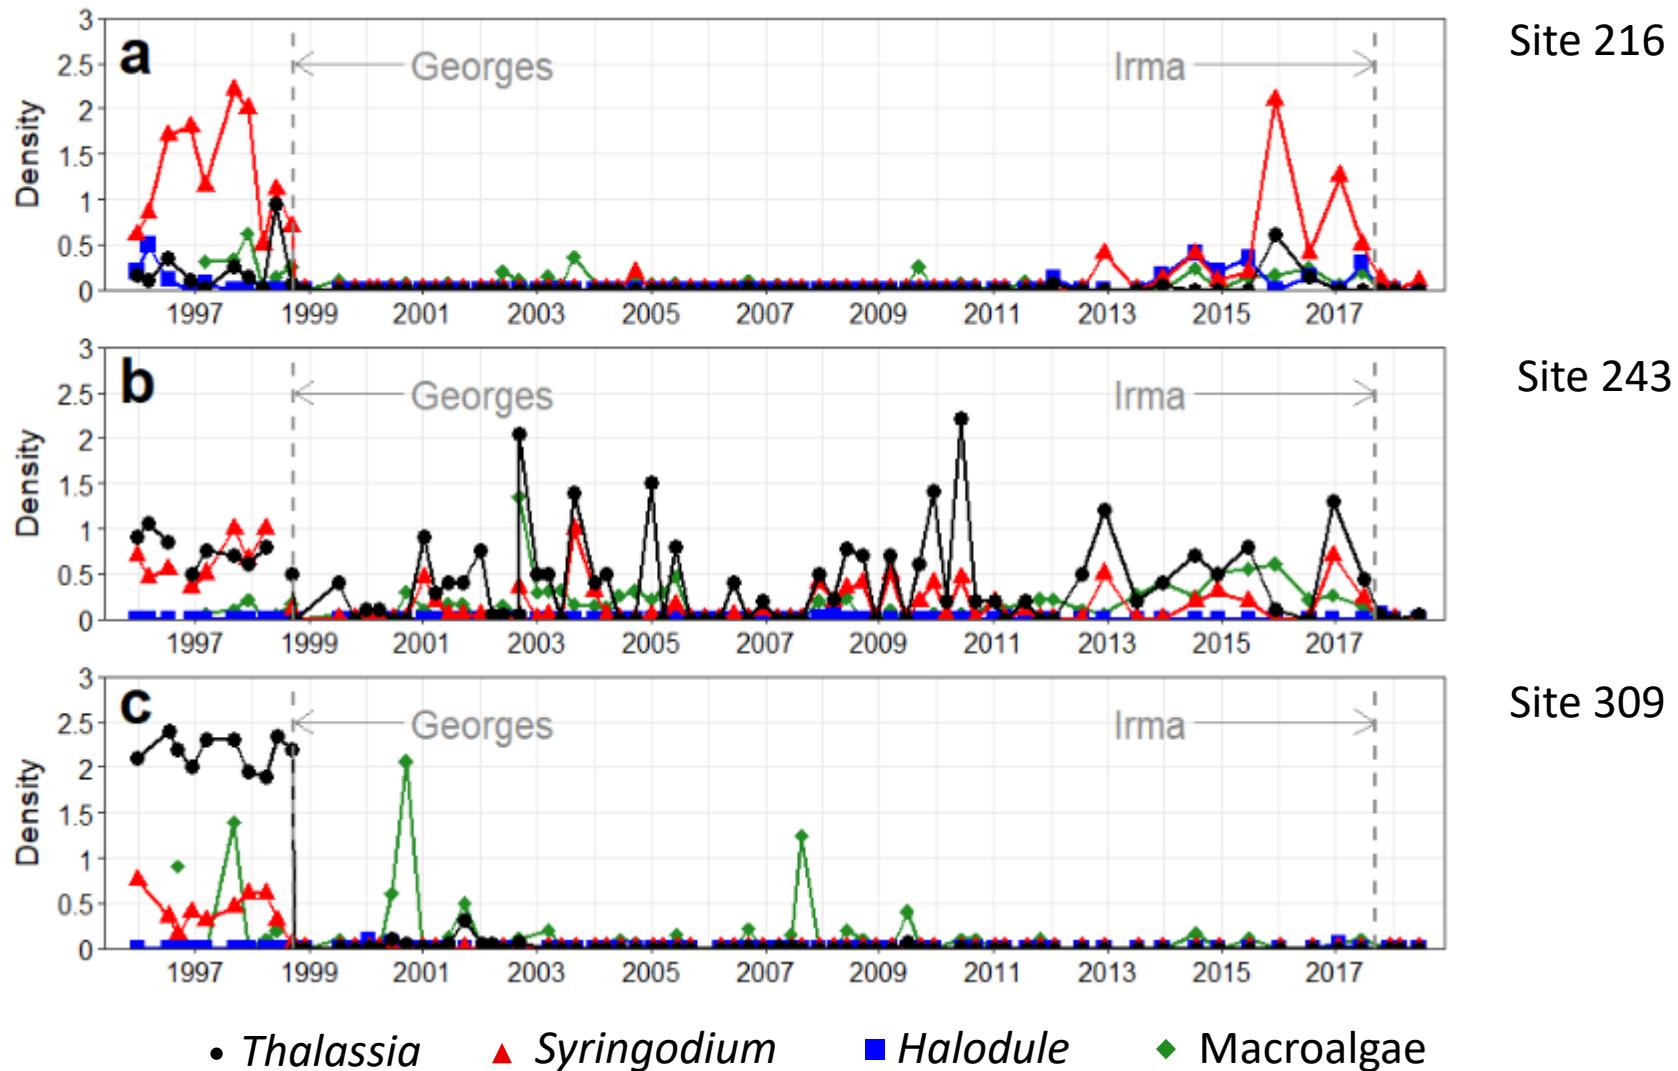
Recovery Trajectories after Hurricane Georges
